Video inspection – seawater barrier valves

Seadrill AS engaged NCA Norway AS to inspect inside the barrier valves onboard West Alpha during normal operations.

SOW: Inspection of 19 seawater pipes w/barrier valves
Location: Northern North Sea
Vessel: West Alpha
Timing: July 2010
NCA Client: Seadrill AS

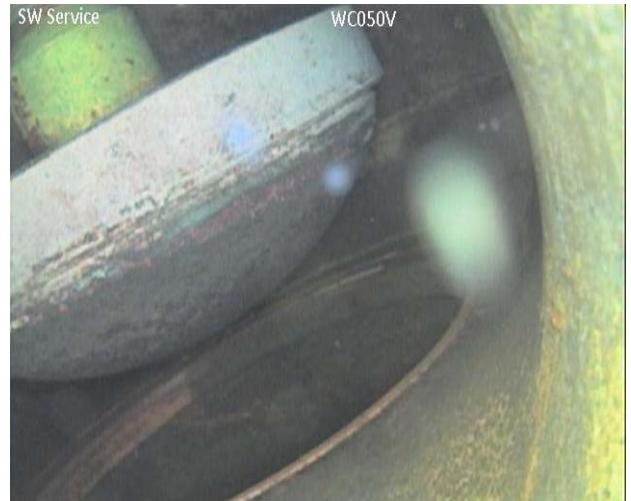
- ✓ 1st barrier valves
 - Dense and watertight
 - Little or nothing corrosion
 - No visible damage
 - Valves are missing guide rod for the valve plate, hence there are sideways movement of the valve plate. Valve plate does not always hit the valve seat correctly
- ✓ 2nd barrier valves
 - One valve is not dense and watertight
 - Little or nothing corrosion
 - No visible damage
 - All remotely operated valves have slow and uneven movement, most likely due to air in the hydraulic system
