## Total-Frigg-Conductor stub removal

### Project Facts and Location: Frigg DP2

Timing: December 2010  
Water depth 100meter  
Client: Aker  
End client: Total

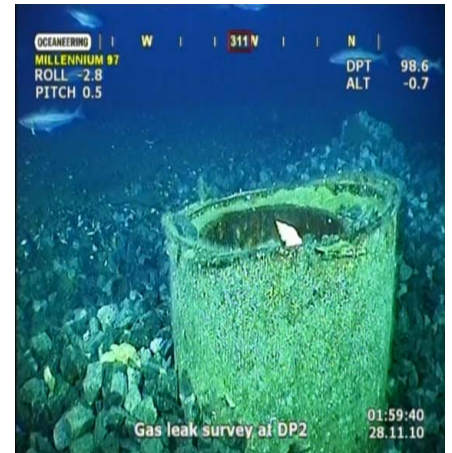
Conductor Stub

NCA used Abrasive Water Jet Cutting (AWJC) with the Internal Multistring Cutting Tool (IMCT) for severance of the conductor stub. The conductor casings were cut from inside out in one operation. This is proven technology with a track record of more than 300 conductors cut, ranging from conductors on 30 metres water depth to 5 string conductors on 370 metres water depth.

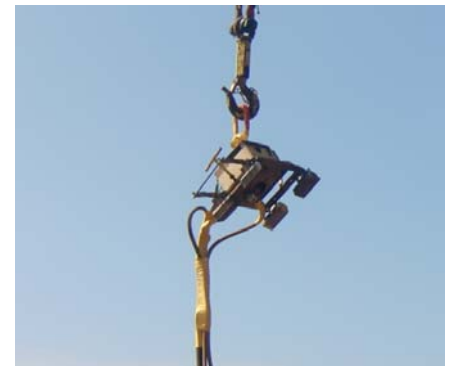
HCT hole cutting tool

NCA's scope of work was to deliver personnel and equipment for cutting the conductor stub 5 feet below mudline and to cut lifting holes in the conductor. Aker Wayfarer then retrieved the conductor stub to deck.

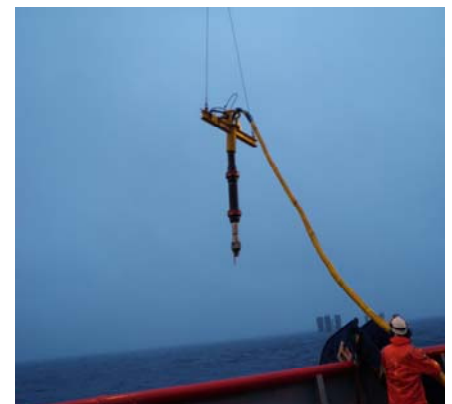
Deployment of IMCT

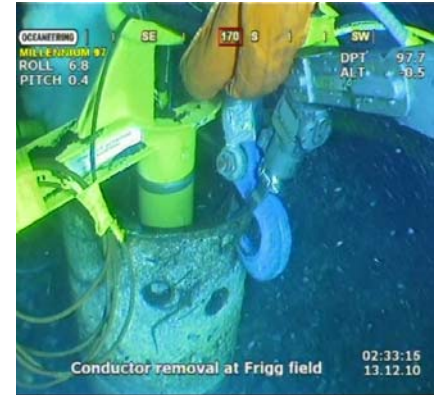
Connecting the crane hook to the stub

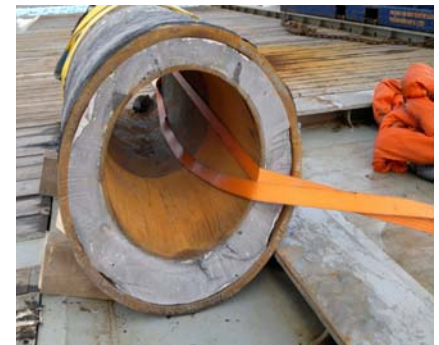
Cut and retrieved Conductor stub
